INDOOR AIR QUALITY ASSESSMENT

**North Andover Town Hall
120 Main Street
North Andover, Massachusetts**

Prepared by:
Massachusetts Department of Public Health
Bureau of Environmental Health Assessment
June, 2001

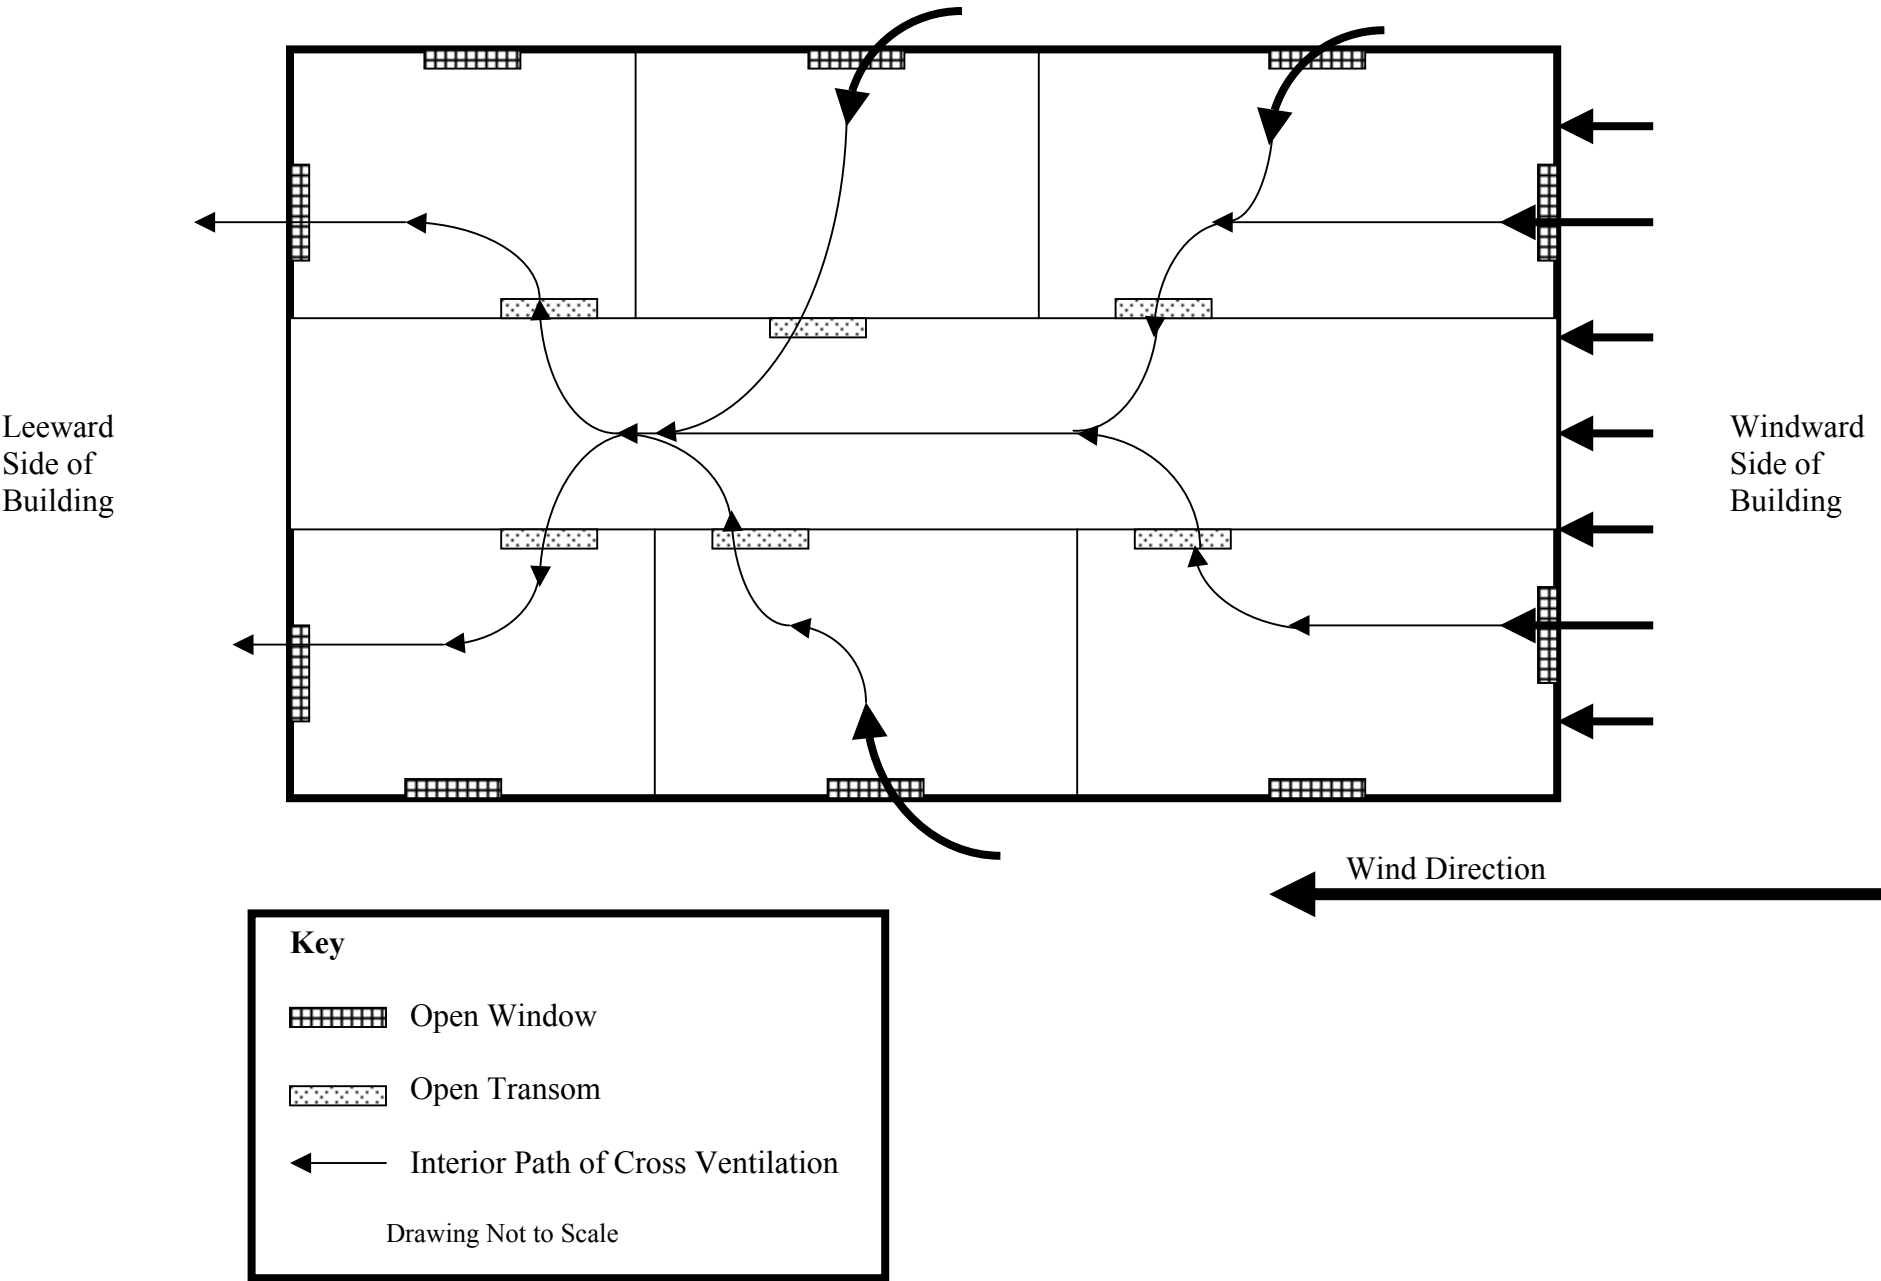
Figure 1

During summer months, ventilation in the town hall is controlled by the use of openable windows. The town hall was configured in a manner to use cross-ventilation to provide comfort for building occupants. The building is equipped with windows on opposing exterior walls. In addition, the building has hinged windows located above the hallway doors. This hinged window (called a transom) enables the classroom occupant to close the hallway door while maintaining a pathway for airflow. This design allows for airflow to enter an open window (windward side), pass through a room, pass through the open transom, enter the hallway, pass through the opposing open room transom, into the opposing room and exit the building on the leeward side (opposite the windward side) (see Figure 1). With all windows and transoms open, airflow can be maintained in a

Cross Ventilation in a Building Using Open Windows and Transoms

8. Use transoms to enhance airflow during warm weather. Be sure to close transoms at the end of business hours. To aid in the draw of fresh outdoor air in warm weather, use portable fans directing air out windows on the leeward side (opposite the windward side) of the building. Fans positioned in this manner will serve to increase the draw of outdoor air across the first and second floors without interfering with the natural internal airflow pattern of the building.

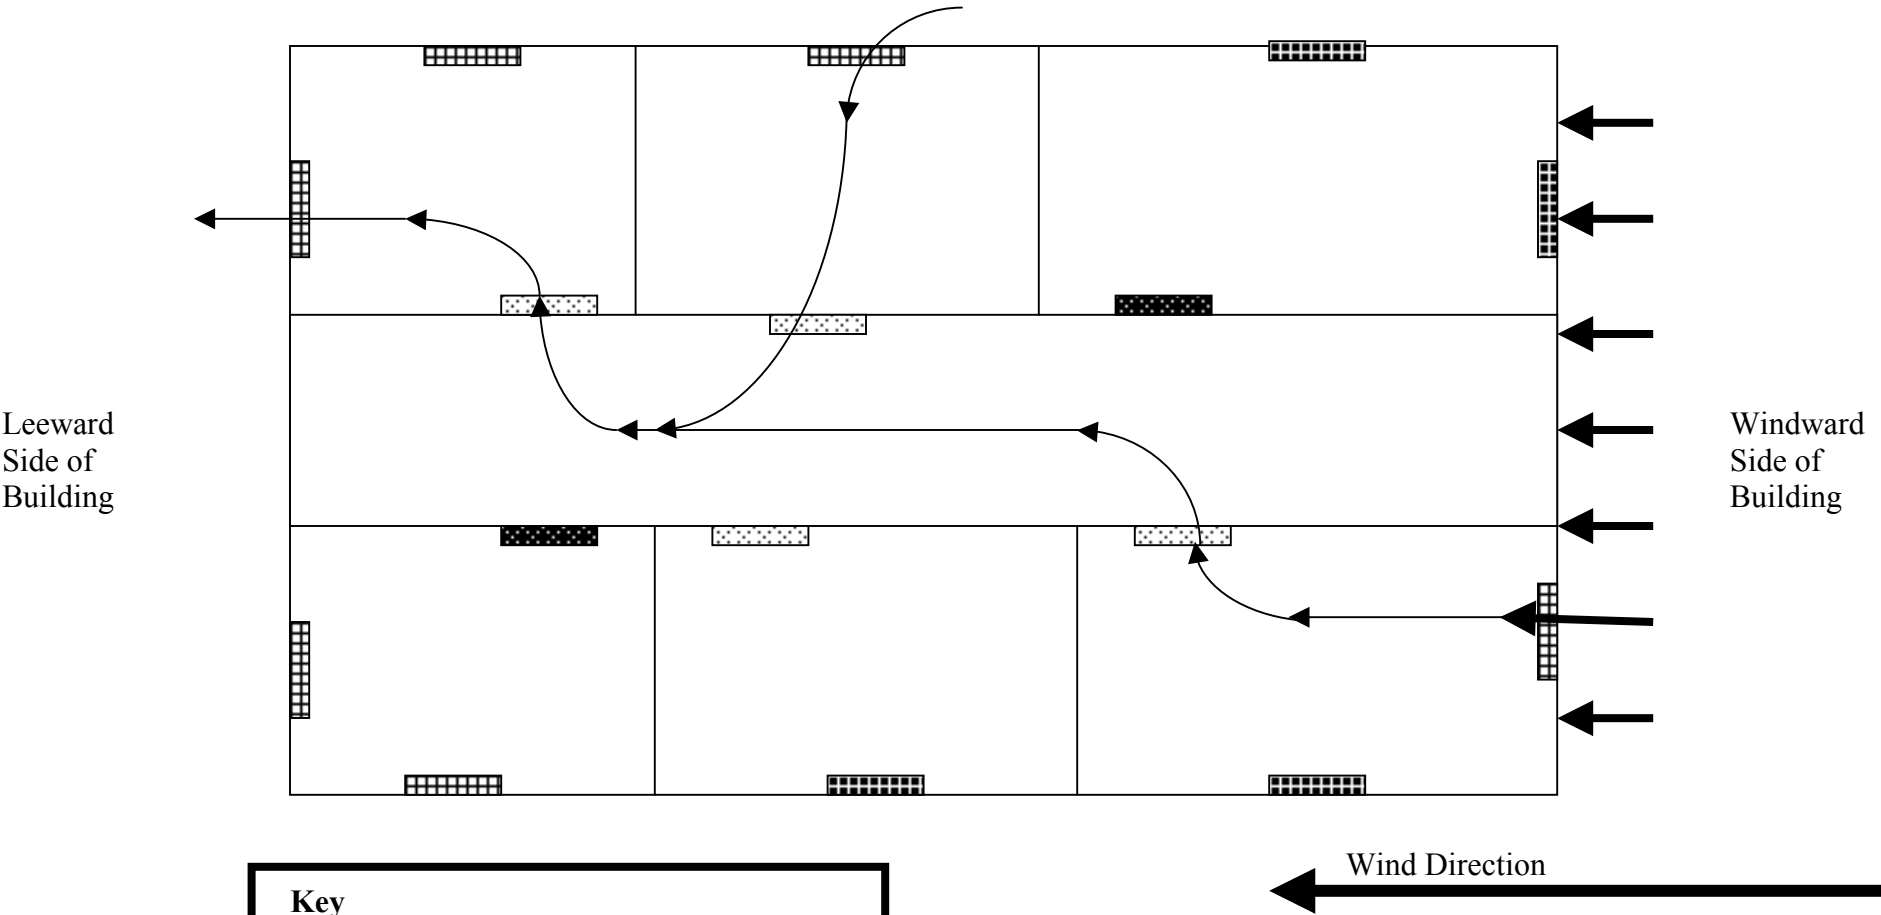
Figure 2 **Inhibition of Cross Ventilation in a Building with Several Windows and Transoms Closed**

building regardless of the direction of the wind. This system fails if the windows or transoms are closed (see Figure 2).

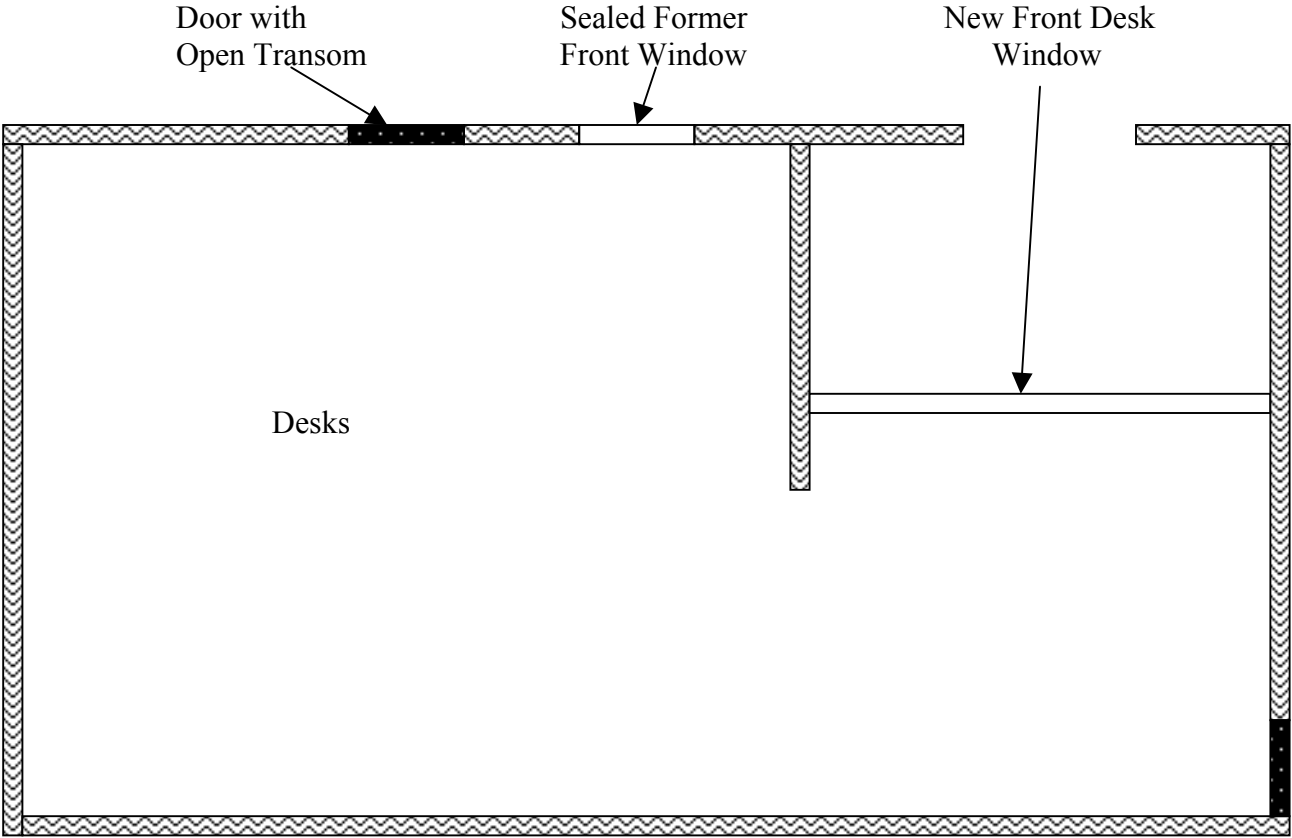
Figure 3

Some offices, such as the tax collector's office, were reconfigured so that airflow to the hallway was altered (see Figure 3). One window that formerly opened to the hallway was enclosed with a recessed front desk and subdivision of the office floor space. The new front desk has glass installed with narrow windows, which restricts airflow. In addition, the tax collector's office contained at least six computer monitors, one fax machine and one photocopier. Each of these electronic devices can produce waste heat, which is expelled into the office space while operating. With the reconfiguration, the ability for air to flow to and from the tax collector's office is restricted.

Configuration of Tax Collector's Office

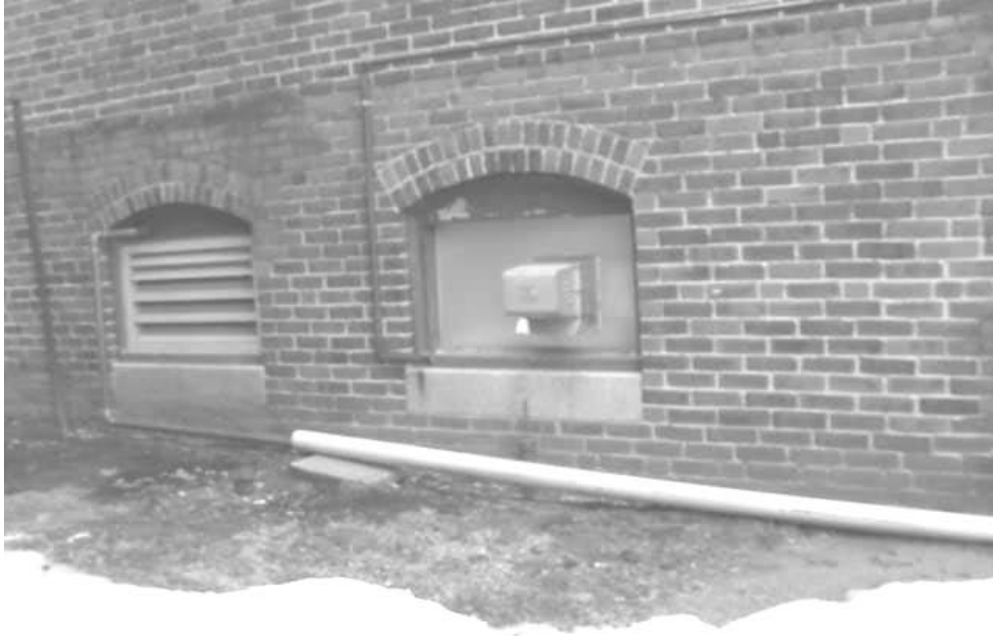
Picture 2

The fresh air intake for the basement AHU is located in half of the original makeup air vent for the furnace. The vent for the AHU is located within the louver of the shared furnace makeup air vent. In this configuration, the AHU has the potential to draw air and related pollutants from the boiler room.

Shared Fresh Intake/Make-Up Air Vent

1. Seal the crawlspace entrance in the fire station basement.
2. Examine the feasibility of installing a return air vent in the basement meeting room.
3. Examine the feasibility of extending the fresh air intake outdoors for the basement AHU in a manner to separate it from the furnace make up air vent.

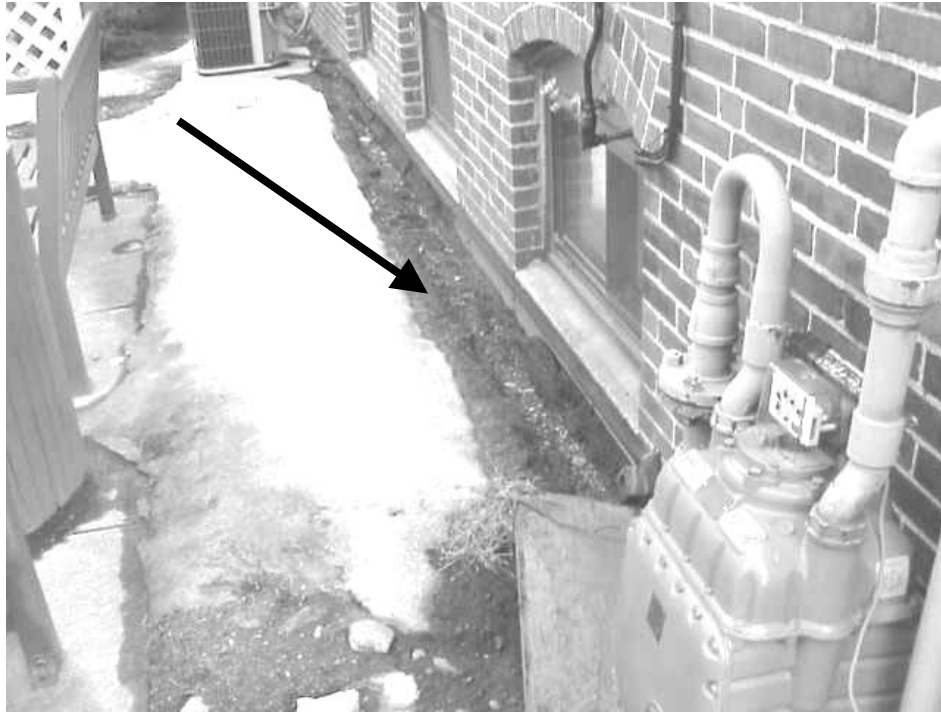
Picture 3

- Soil along the base of the building has a deep furrow caused by rainwater runoff from the building wall (see Picture 3), which is evidence of poor drainage.
- A damaged downspout exists on the front of the building (see Picture 4).
- The condensation drain for the air-conditioning system also exits the building through a basement office window frame along the exterior wall base near the chiller (see Picture 5).
- Shrubbery in direct contact with the exterior wall brick was noted along the front of the building (see Picture 6). Shrubbery can serve as a possible source of water impingement on the exterior curtain wall due to the location of plants growing directly against the building. Plants retain water and in some cases can work their way into mortar and brickwork causing cracks and fissures, which may subsequently lead to water penetration and possible mold growth.

Furrow from Rainwater Runoff

12. Improve drainage along the exterior wall to direct rainwater away from the base of the building.
13. Extend the condensation drain to empty at ground level to prevent water splashing and further damage to window frame.

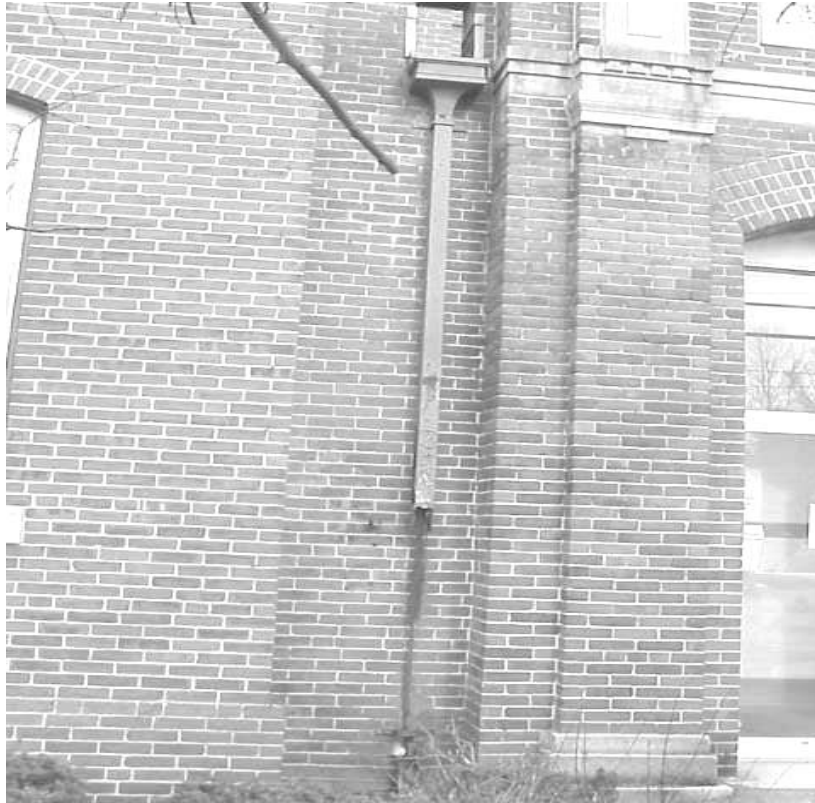
Picture 4

Damaged Down Spout at Front of Building

9. Repair damaged window frames to prevent water penetration into the building.
10. Replace water damaged and missing ceiling tiles.
11. Repair downspout system.

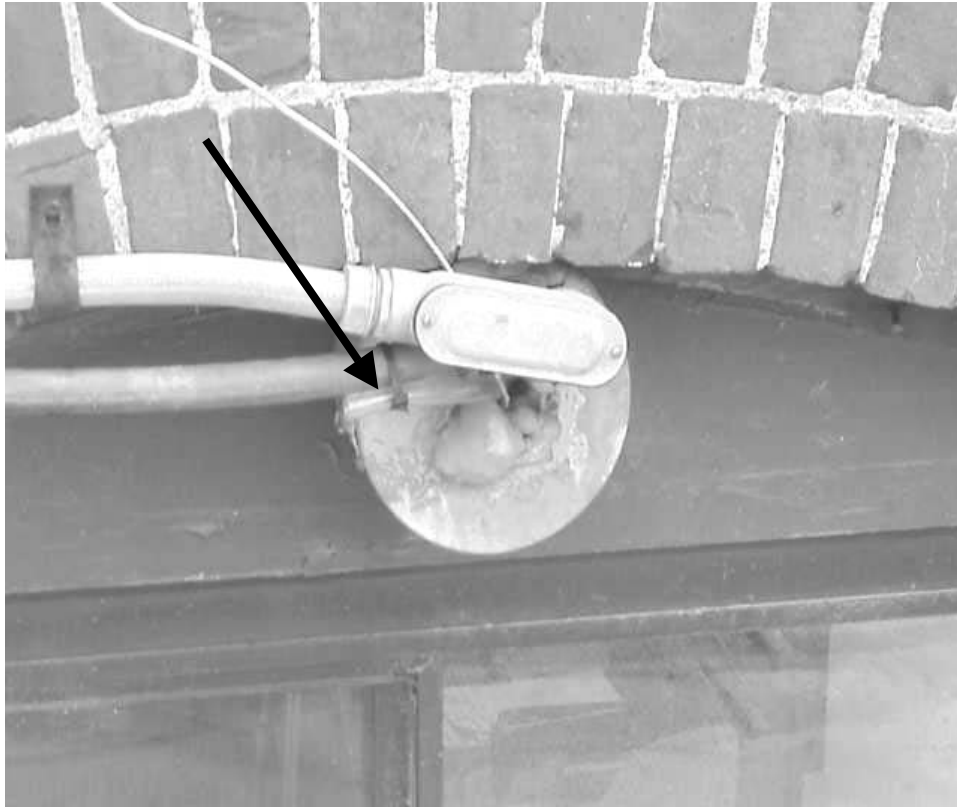
Picture 5

Air-Conditioner Condensation Drain

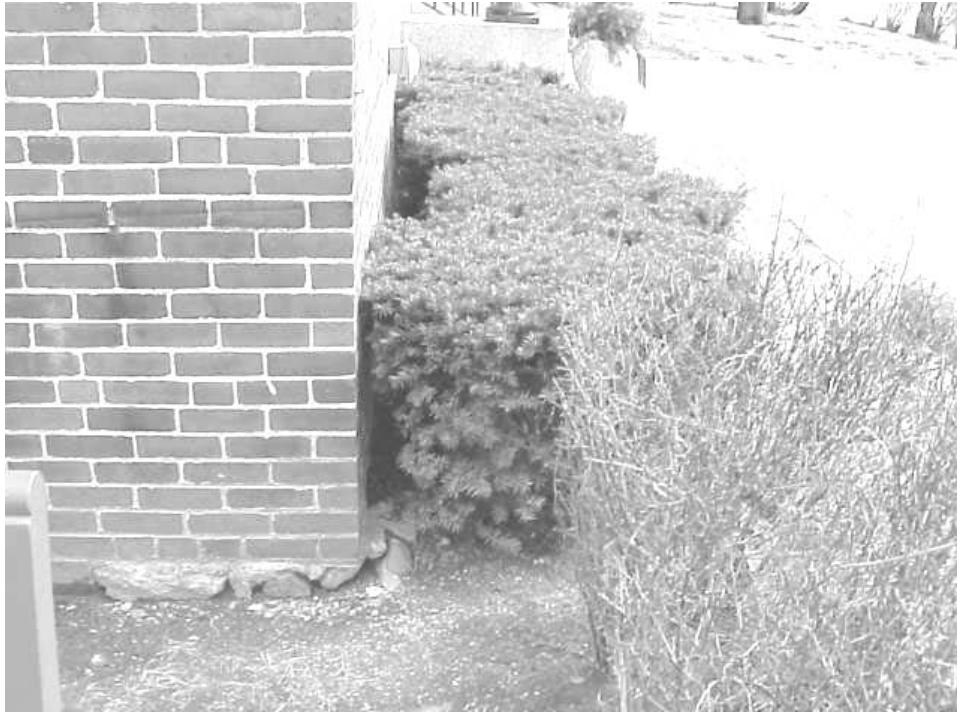
Picture 6

Shrubbery against Exterior Wall

14. Cut back or consider removing shrubbery from the exterior wall of the front of the building.

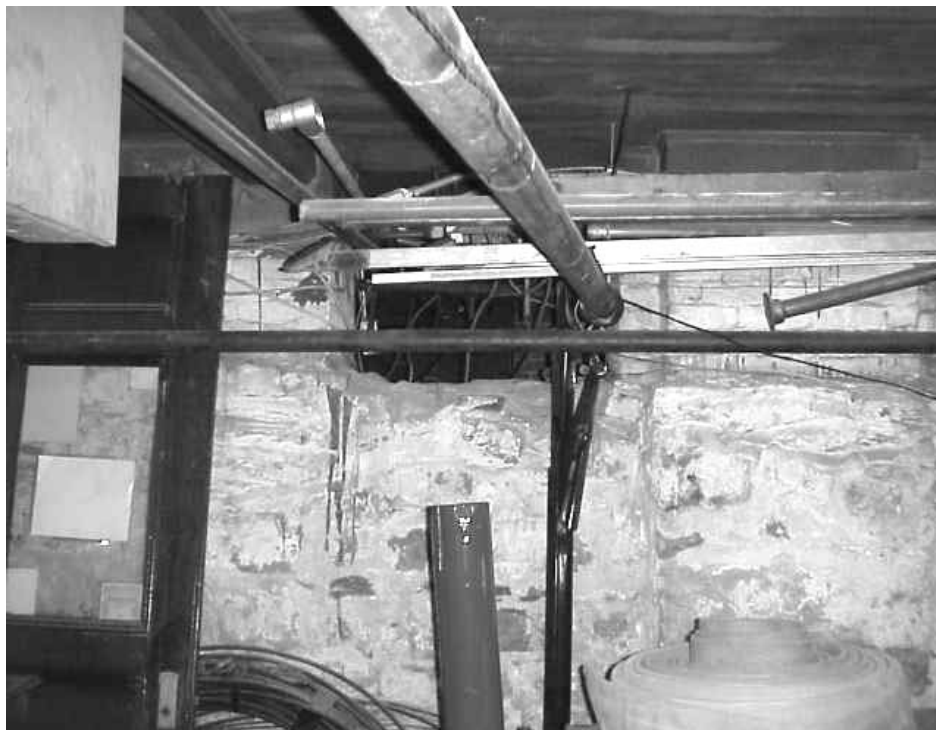
Picture 7

Missing and ajar ceiling tiles, as well as spaces and holes in the interior walls and floors were observed. Since wall cavities are unconditioned space and would be expected to have a lower temperature than heated offices, drafts of air moving from the wall interiors into rooms may occur. Particulates can move with airflow from the interior of the wall cavity into the room. Each of these breaches in the floors and walls can be a means for odors and particles to move from one area to another. The town hall has a crawl space that can be accessed from an opening within the basement of the fire station (see Picture 7). Stored in the firehouse basement are several pieces of fossil fuel powered equipment, including the emergency electrical generator. This opening between the buildings can serve as a means for odors to move from the fire station basement into the town hall crawlspace. Once in the crawlspace, pollutants could potentially move into the ground and first floor through spaces in floors or walls.

Hole in Town Hall/Fire Station Shared Wall
